MULTIDISCIPLINARY ACCIDENT INVESTIGATION TEAM NARRATIVE/DIAGRAM

SL-054-13

MAIT SUPPLEMENTAL

This investigation was conducted by the California Highway Patrol (CHP) Southern Division Multidisciplinary Accident Investigation Team (MAIT).

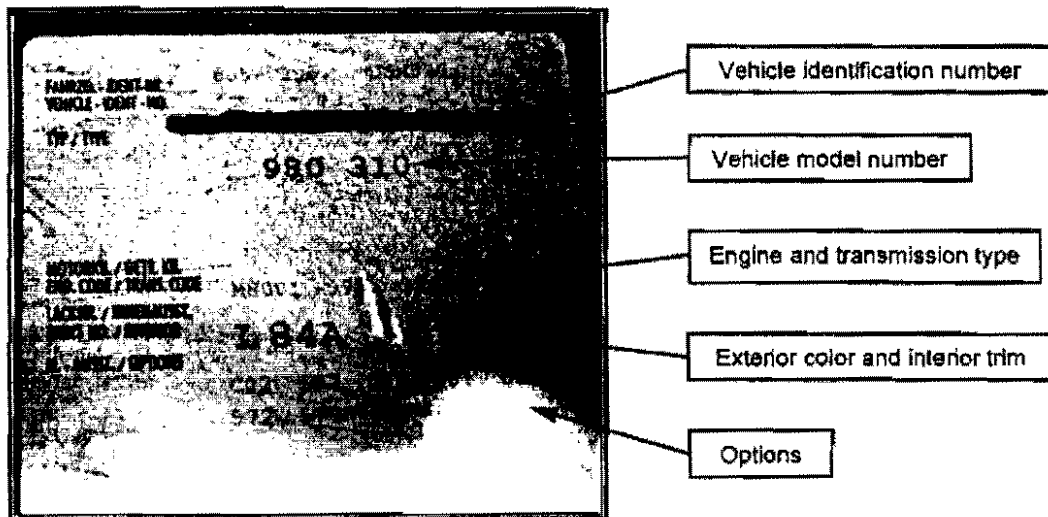
Figure 1: Vehicle information label. (LASD photograph IMG_0122.JPG)

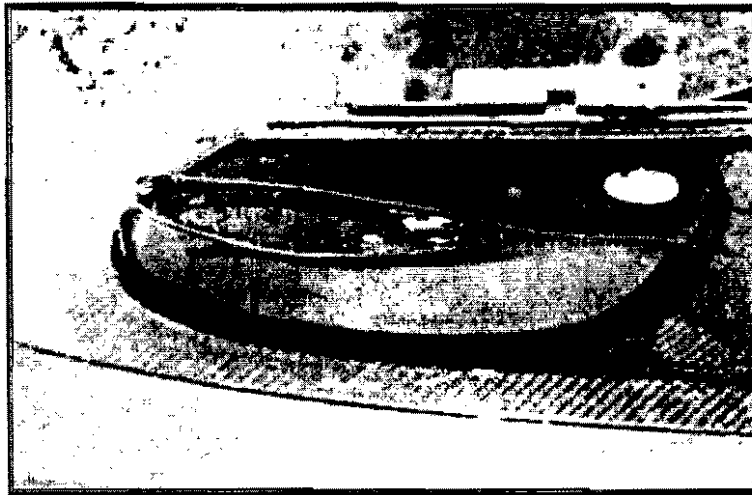
Figure 5: The separated left door panel airbag cover. (LASD photograph IMG_0081.JPG)

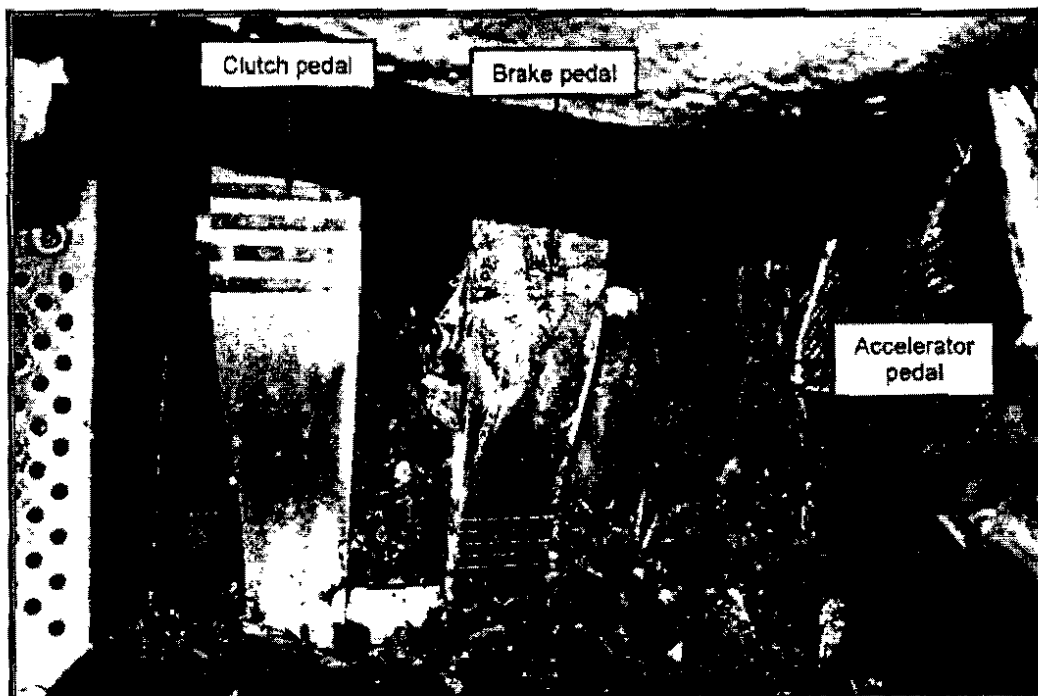
The area in the vicinity of the accelerator pedal was inspected. The floor and the area surrounding the accelerator pedal were damaged from the post-collision fire. The accelerator pedal was capable of being moved, but its movement was restricted and rough. The majority of the electrical components associated with the accelerator pedal were consumed in the post-collision fire.

Figure 13: The pedal cluster of Vehicle #1. (LASD photograph IMG_0226.JPG)

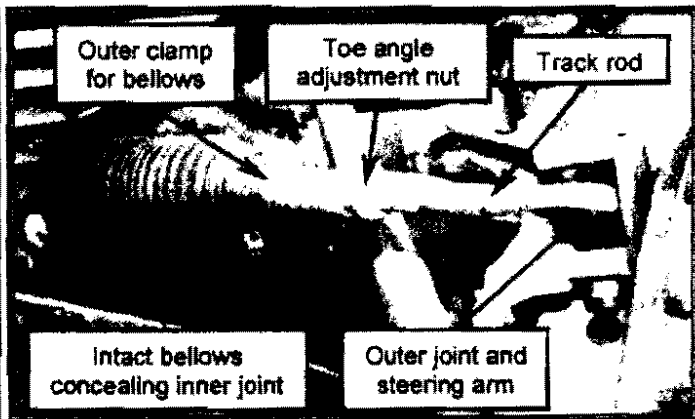
Figure 18: Left bellows and track rod of Vehicle #1.
(LASD photograph IMG_0222.JPG)
